NITROGEN TETROXIDE CORROSION STUDIES OF CRYOPANEL MATERIALS FOR SPACE CHAMBER PROPULSION TESTING

P. G. Waldrep and D. M. Trayer

ARO, Inc.

October 1968

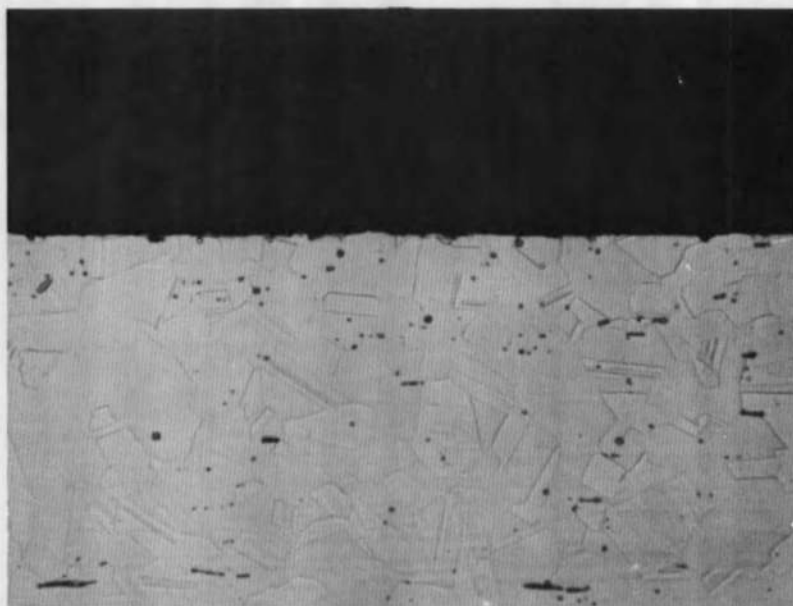
Fig. 8 Control Specimen, Stainless Steel 304L, 500X

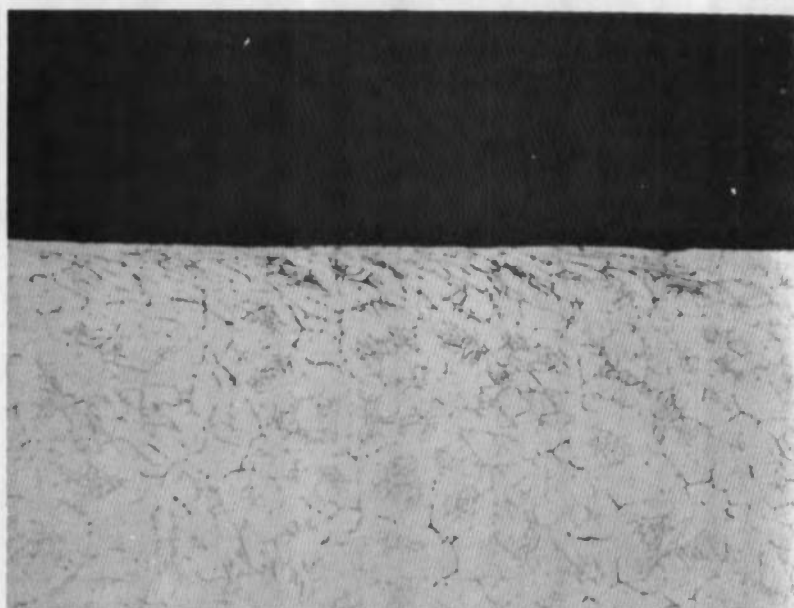
Fig. 16 Stainless Steel 304L, Stressed, at 347 Rod Weld, Exposed
720 hr to Cryodeposit, 2816hr to Gas, 20 cycles, 500X

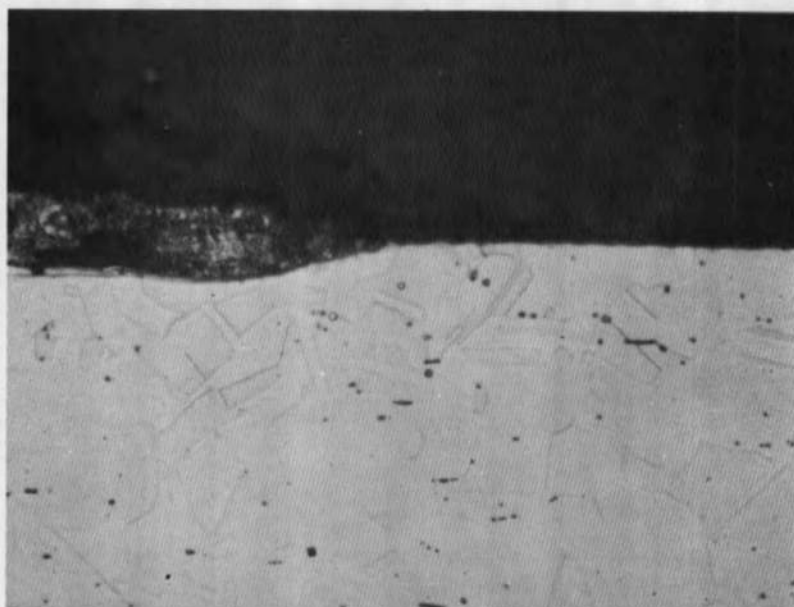
Fig. 17 Stainless Steel 304L, at Resistance Spot Weld, Exposed
720 hr to Cryodeposit, 2816 hr to Gas, 20 cycles, 500X

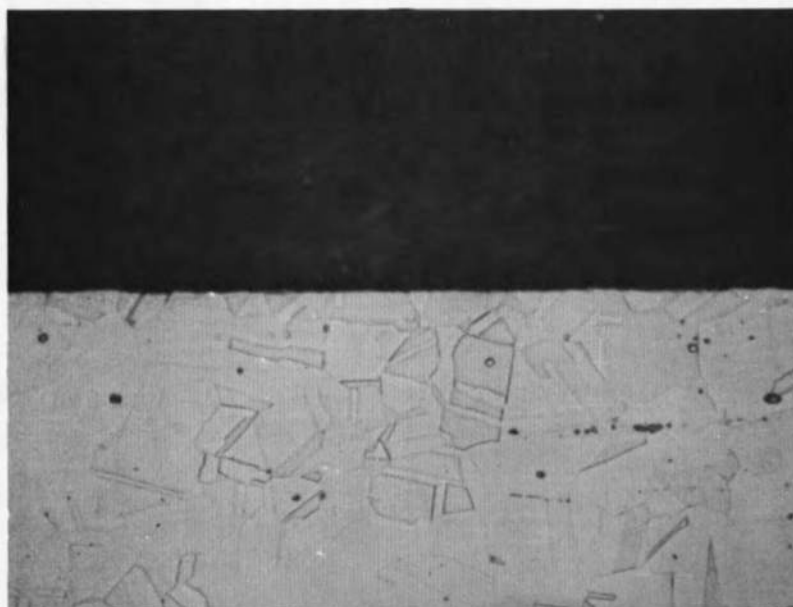
Fig. 18 Stoinless Steel 304L, Welded with 304L Rod, Epoxy Cooted, Exposed 58 hr to Cryodeposit, 441 hr to Gos, 9 cycles, 500X

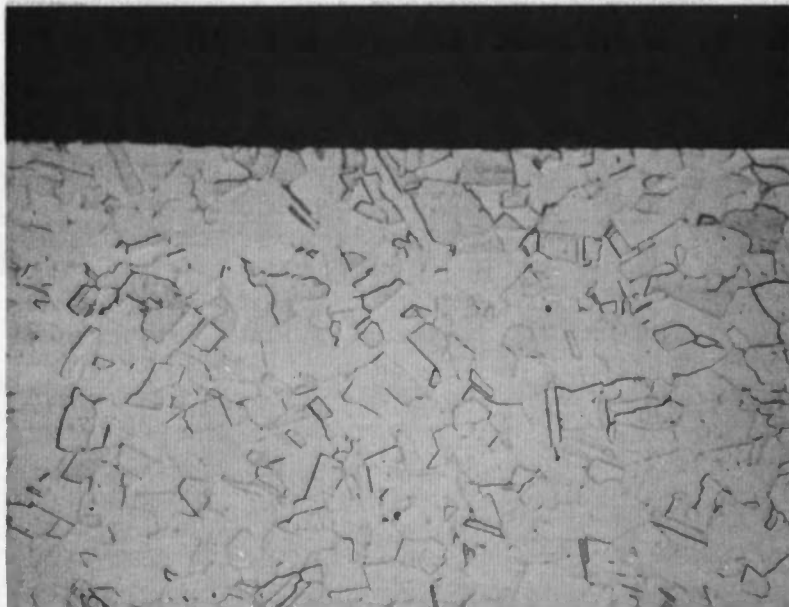
Fig. 22 Control Specimen, Unbrazed Copper, 500X

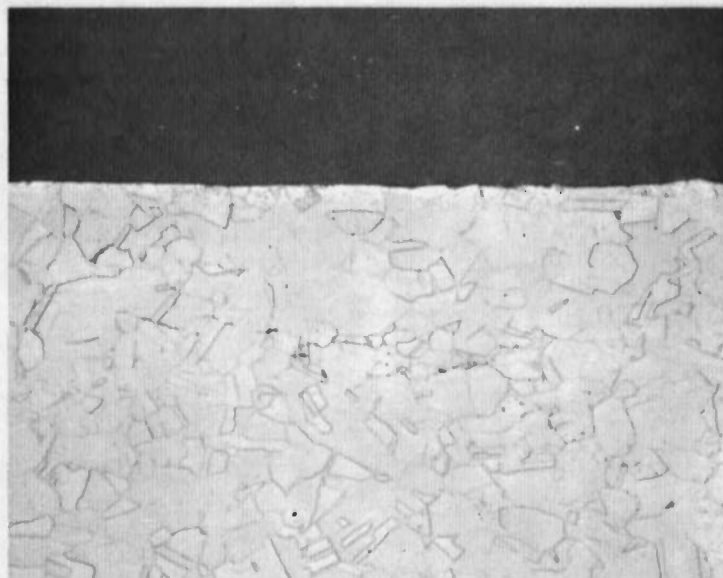
Fig. 23 Unbrazed Copper, Contacted Copper Fin, Exposed 58 hr to Cryodeposit, 441 hr to Gas, 9 cycles, 500X

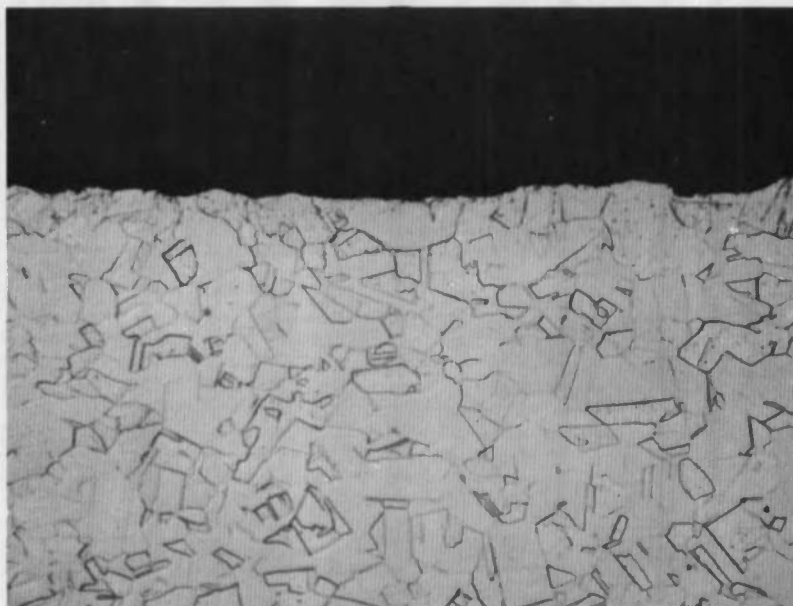
Fig. 24 Brozed Copper, Contacted Copper Fin, Exposed 420 hr to Cryodeposit, 1190 hr to Gas, 8 cycles, 500X

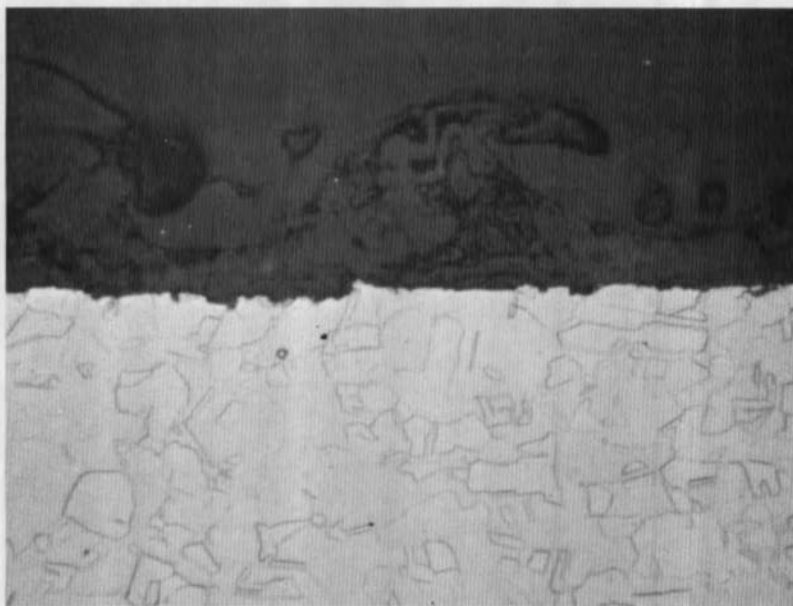
Fig. 25 Unbrozed Copper, Contacted Aluminum Fin, Exposed 720 hr to Cryodeposit, 2816 hr to Gas, 20 cycles, 500X

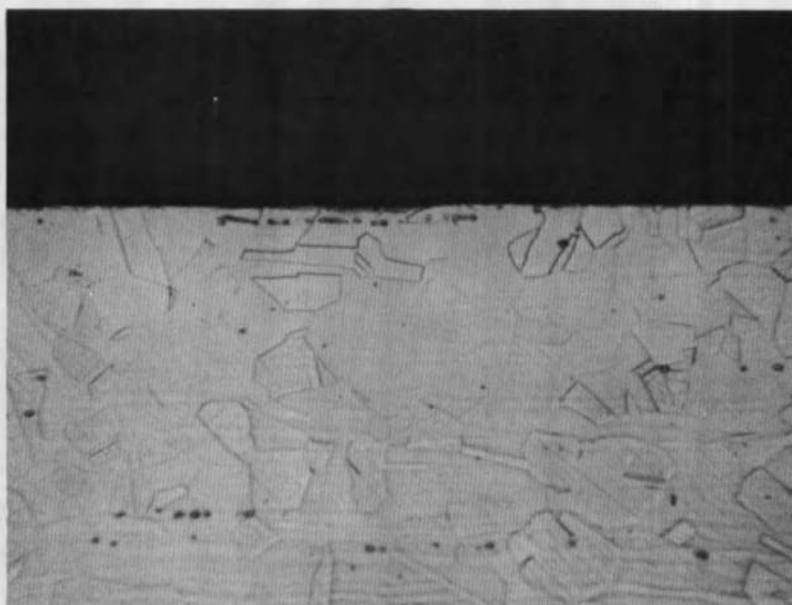
Fig. 32 Composite Specimen, Stainless Steel Side, Exposed 58 hr to Cryodeposit, 441 hr to Gas, 9 cycles, Stressed, 500X

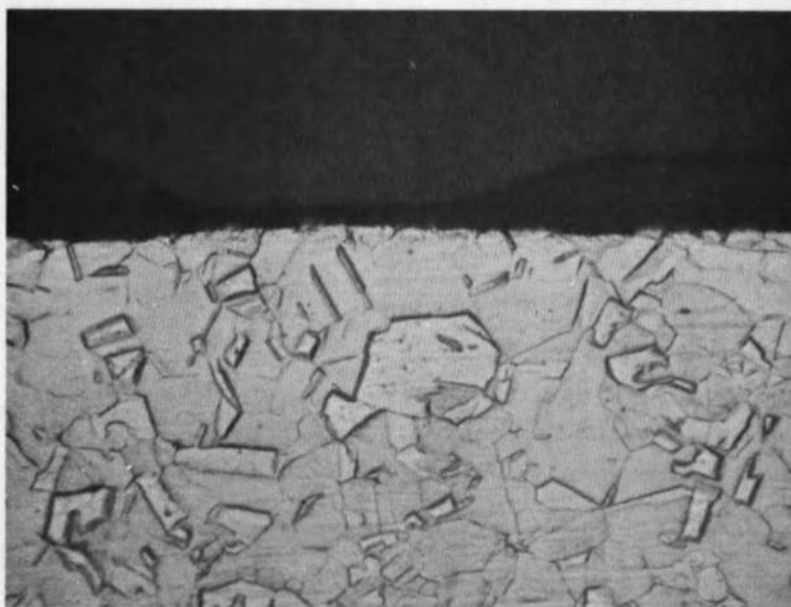
Fig. 35 Composite Specimen, Copper Side, Exposed 58 hr to Cryodeposit, 441 hr to Gas, 9 cycles, Stressed, 500X

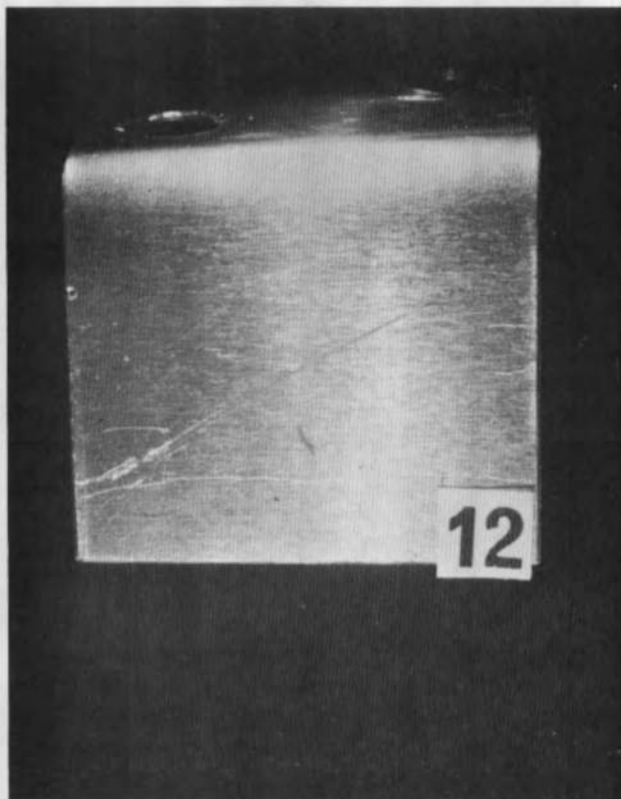
Fig. 36 Aluminum, Contacted Aluminum Fin, Exposed 720 hr to Cryodeposit, 2816 hr to Gas, 20 cycles, 3X

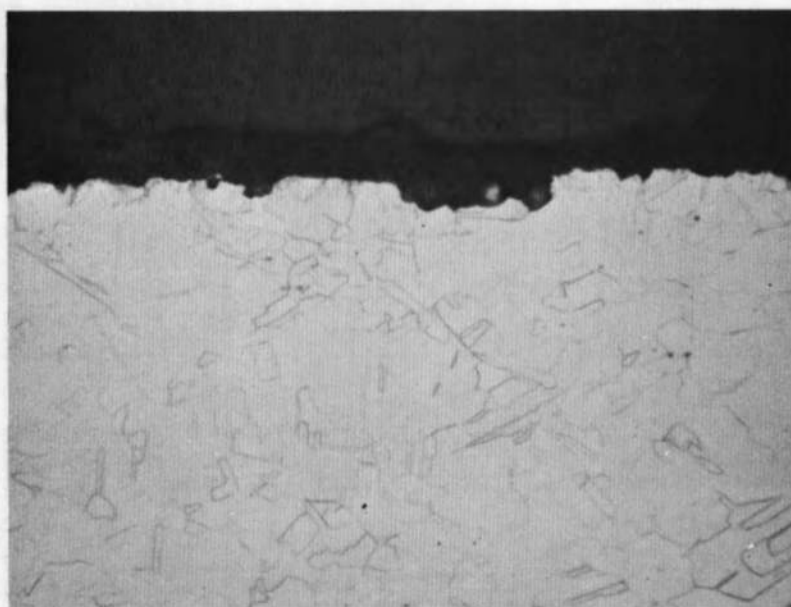
Fig. 47 Copper Cryopanel, Uncoated Side, Exposed 298 hr to Cryodeposit, 1629 hr to Gas, 12 cycles, 500X
